FIELD INSPECTION

Project Name:	Mountain Valley Pipeline	Inspector:	Matthew Grant
Inspection Date:	Wednesday, August 7, 2019	Project Contact:	Cory Chalmers
Spread: Montgomery County MP236-237 St12475-12543+56 AR278.01	Spread H	Weather (Wet/Dry/Rain):	Dry
STAGE OF CONSTRUCTION: (Check all that apply)			
Clearing	Rough Grading	Trench Excavation	Pipe Assembly, Testing & Installation
Backfilling and Grade	Restoration Final Grading	& Stabilization	Other: Voluntary SW & SWO area
are all control meas condition in accorda applicable, manufac Areas of offsite sedi	d and implemented in accordance with the nt control plan and stormwater manageme ures properly maintained in effective oper nce with good engineering practices and, turer specifications? ment deposition were observed?	ent plans? rating	
 Inspected designated stream and wetlands included: S-CD12, WKL 58, S-IJ-19, S-EF54. The inspection conducted included the area between St12475 through St12482+67 and the area within the SWO St 12494+25 through12543+56. Areas within the SWO were actively being repaired, sediment removal was on going on designated streamS-IJ-19. Areas within St12475 and 12482+67 require stabilization. St12476+40 ump

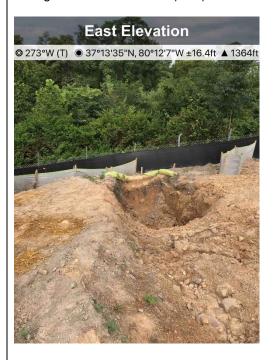
Fig. 3. St12479+80 sump requires to be built to spec

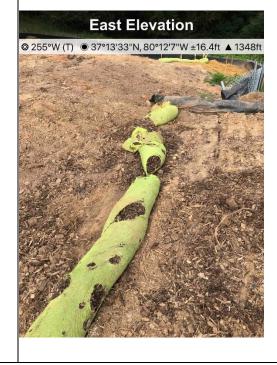
Fig. 4. St 1248 bridge waddle requires replacement

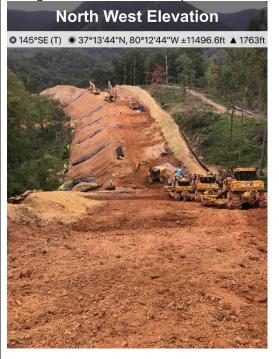
Fig. 11 Near CWD and slope drains at St 12534+37
